# FAREHAM BOROUGH COUNCIL

## Buildings at Risk Survey

2006

FORUM  
Heritage  
Services

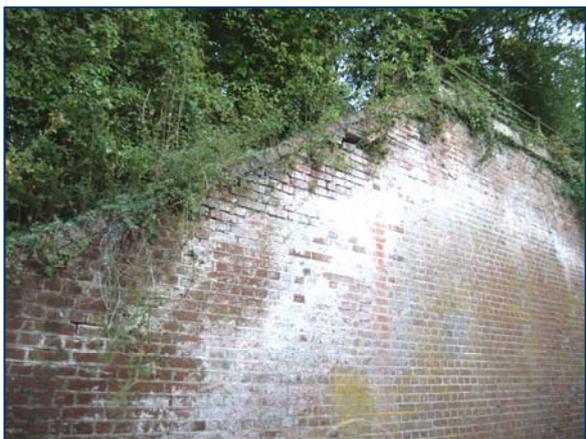
Only the publicly accessible elements of the fort were surveyed and it is recommended that this particular building is surveyed regularly to flag up potential major problems before they become catastrophic. This building needs constant repair and consolidation on a sensible revolving programme if it is to have any chance of surviving in its substantially intact state that is at present showing signs of significant erosion.

**Figure 2:** *excessive vegetation to wall cappings*

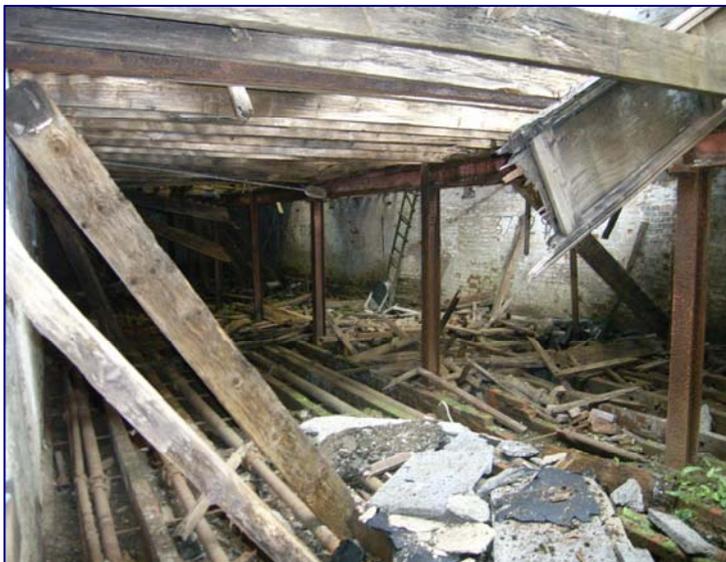
spaces to provide teaching facilities, study areas and small exhibition spaces. Drying Shed No.2 however remains at grave risk. The modern roof has completely failed in places and is letting in water. The fabric of this building is showing significant signs of decay with much vegetation in open joints and to the wall cappings (Figure 4).

**Figure 4:** Drying shed 2  
Burseldon Brickworks – roof has completely failed

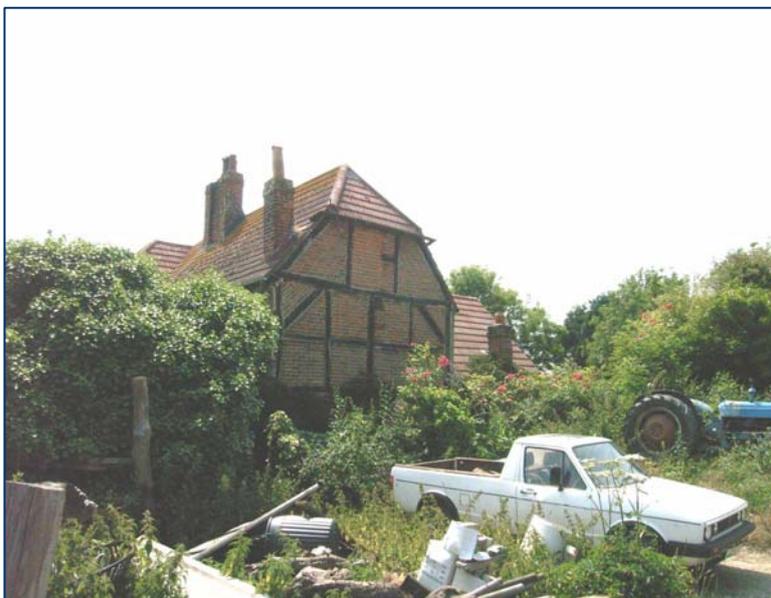
**Figure 5:** Foxbury Cottages, 1 Newgate Lane, Fareham – Secure but unoccupied

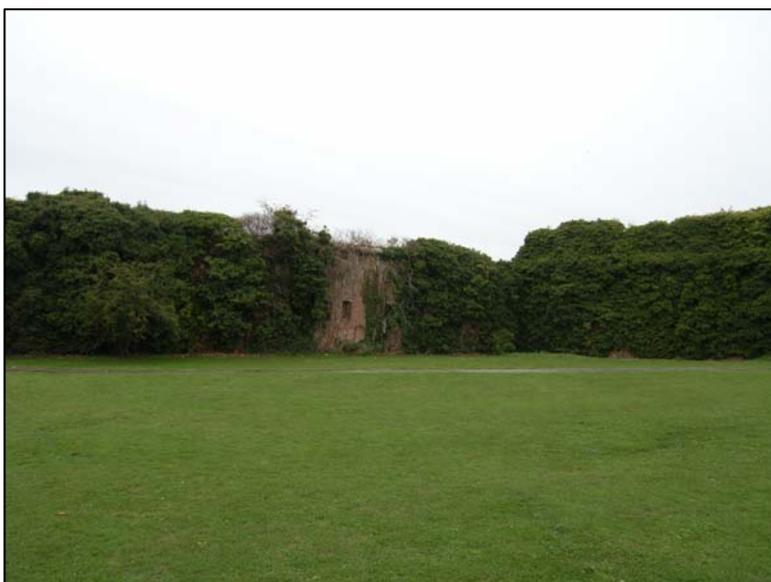
**Figure 8:** Fort Wallington – Excessive invasive vegetation restricts survey and could cause damage to structure

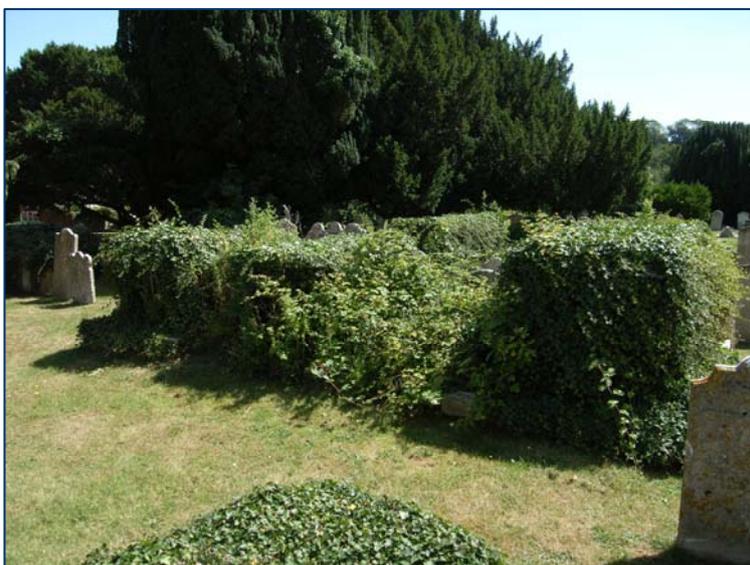
It should also be noted that two of these entries recording buildings at risk with a risk index 3 or lower are entries with multiple structures, namely the churchyard monuments of the Church of St Peter, Titchfield and the Church of St Peter and St Paul, Fareham. Both churchyards contain some fine examples of church monuments including eighteenth century chest tombs some formerly railed, sculpture and elaborate headstones from the Victorian Period. Both churchyards contain in excess of 30 monuments of various periods and condition. Almost all are covered by thick, penetrating vegetation (Figure 9, often ivy which finds root in the fine joints of the ashlar work and prises the stonework apart. In the case of the chest tombs this can be disastrous for the structure as well as extremely dangerous to members of the public with potentially unsafe sections of substantial stonework.

**Figure 9:** Chest tombs St Peter's churchyard Titchfield, completely engulfed in aggressive vegetation
