# FAREHAM BOROUGH COUNCIL

## Buildings at Risk Survey

2006

FORUM  
Heritage  
Services

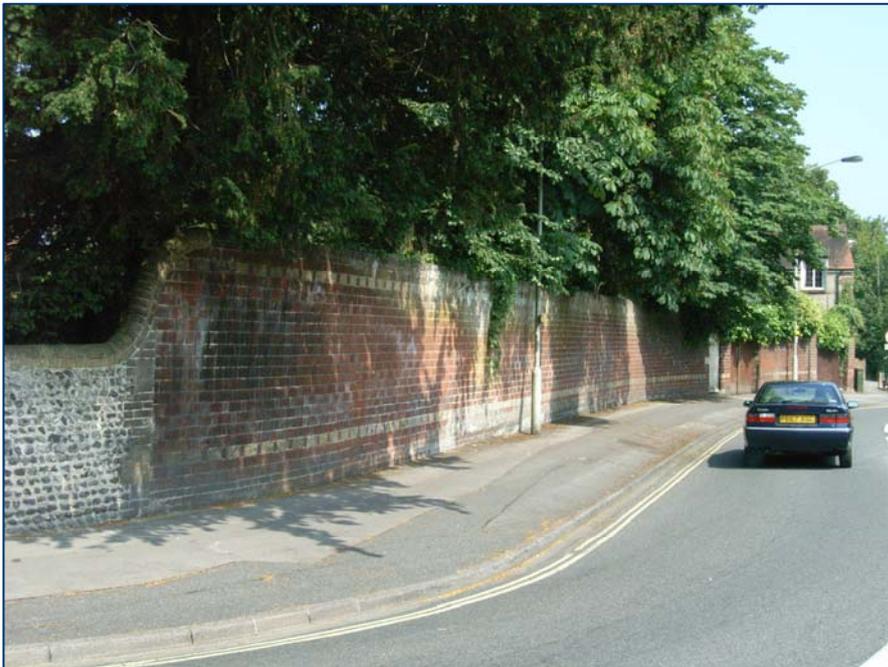
Boundary walls often form very important parts of the character and appearance of conservation areas (Figure 12); Titchfield and parts of Fareham having good examples, yet they are seen by many owners as an unnecessary expense for which there is no return for their outlay. With the increased difficulty in finding good contractors to undertake traditional work (repointing in lime for example) the cost is becoming a significant issue for many owners. This was one of the reasons why Hampshire County Council targeted this building type for grant aid in the 1990's which some considerable success across the County.

With over 70% of those curtilage boundary walls surveyed being at risk or vulnerable this could become a very serious problem in the short term. It should also be borne in mind that boundary walls at risk or vulnerable make up over 35% of the total number of curtilage buildings surveyed as part of this project.

**Figure 12:** Rat trap bond wall with distinctive decorative string courses forming a very striking and attractive part of the local historic street scene in Fareham
